NAVAL POSTGRADUATE SCHOOL

THESIS

**CHARACTERIZATION OF ALUMINUM-MAGNESIUM
ALLOY REVERSE SENSITIZED VIA HEAT TREATMENT**

September 2016

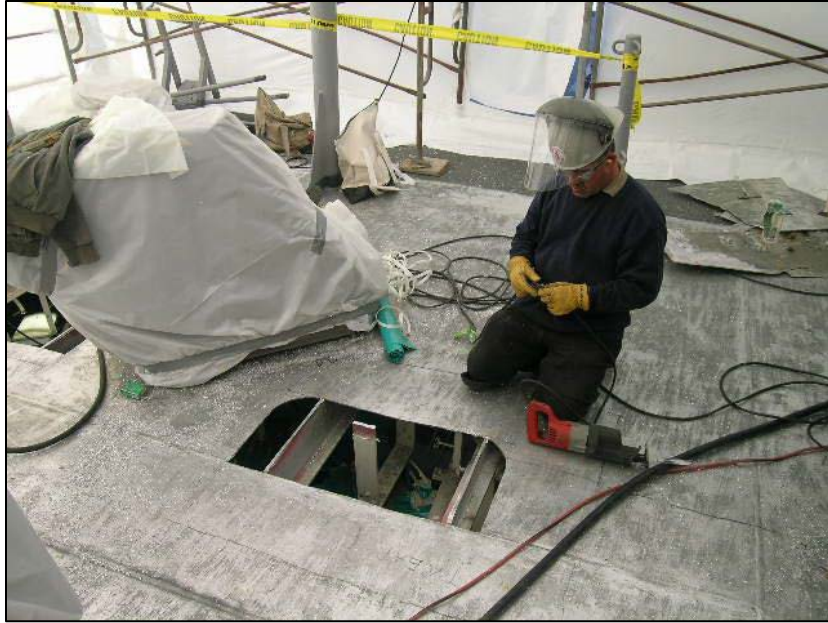
Figure 2. A Worker Prepares to Replace a Stress Corrosion Cracking Damaged Ship Section. Source: [3].

The U.S. Navy spends approximately \$5 million per ship per year in maintenance due to SCC of Al-Mg alloys and \$2.5 billion annually in total Navy ship corrosion-related costs [4], [5]. As the Navy builds more ships with Al-Mg alloys, there is a need to reduce repair costs either by developing lower cost repair techniques, or preventing damage from occurring, or both. Current repair techniques involve cutting out sections of the SCC-affected structure and welding in new material, as shown in Figure 2. This process is expensive because of the material and the skilled welders required to perform the repair. The worker has cut out damaged deck plate and has cleaned and prepared the surface for welding a new insert plate. This is a messy and invasive procedure. The time required to effect repairs lowers operational availability of the ship being repaired, and decreases readiness of the fleet. There is a need to develop a new repair technique that is faster, less expensive, and less intrusive than cutting and welding new aluminum sections on every ship.

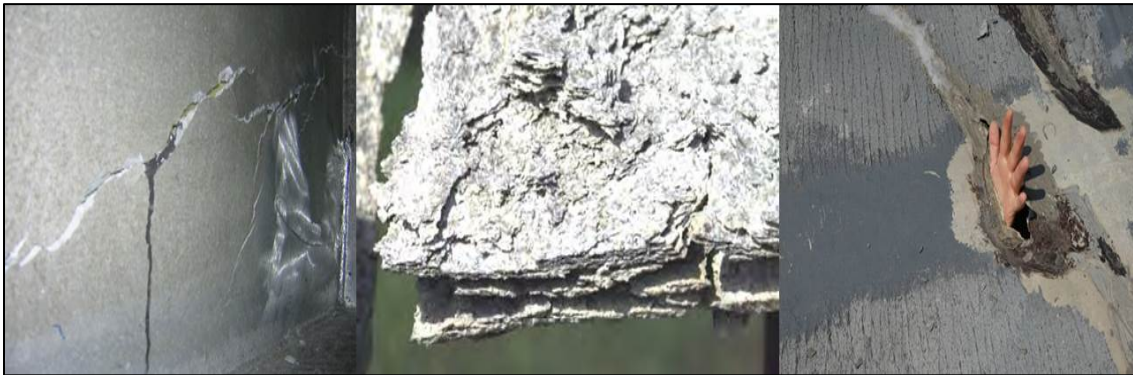
Figure 4. Stress Corrosion Cracking, Exfoliation, and Hole Formation, Respectively, due to Sensitization. Source: [4].

Al-Mg alloys become susceptible, however, if they become "sensitized." Once sensitized, all three elements are present for SCC of the Al-Mg alloys to occur. Over time, the material may crack and/or exfoliate. SCC in Al-Mg alloys is intergranular in nature [7]. The term intergranular stress corrosion cracking (IGSCC) is often used when discussing SCC in aluminum alloys. Shown in Figure 4, from left to right, are the effects of cracking, exfoliation, and formation of a significant-sized hole.

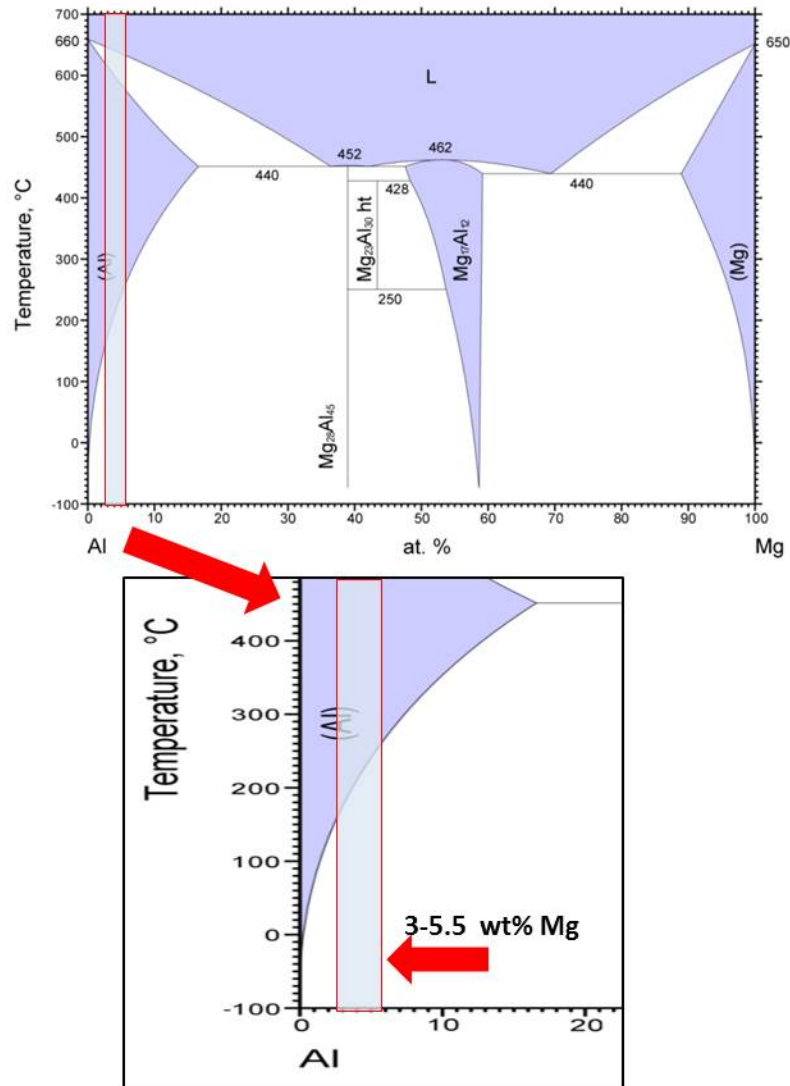
Figure 6. Al-Mg Phase Diagram. Adapted from [12].

Sensitization of 5XXX series Al-Mg generally occurs at service temperatures above 65°C (150°F), which can be reached upon exposure to direct sunlight or in locations near engine compartments [10]. Sensitization has been known to occur at temperatures as low as 50°C (122°F) when exposure is prolonged [11]. This phenomenon can be understood considering the Al-Mg phase diagram in Figure 6. AA5456 has 4.7–5.5 wt% Mg. Locally, this percentage can be lower. To some extent lower Mg content lowers the temperature at which material will become sensitized. Sensitization only occurs in Al-Mg alloys with more than 3 wt% Mg [7], [11]. The microstructures of as-received (non-sensitized) material and in-service material cut from an active Navy Cruiser (partially sensitized) are shown in Figure 7. The qualitative assessment of sensitization can be seen in the darker, more continuous grain boundaries formed by β -phase precipitate, in the in-service material.

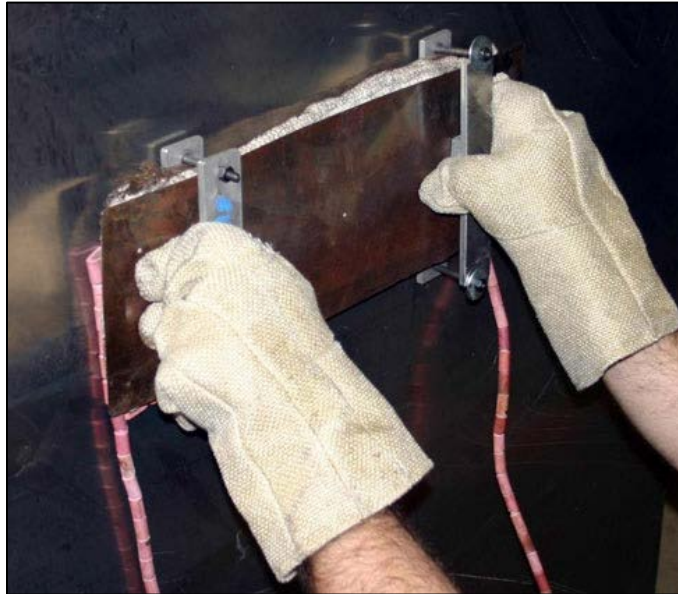
Figure 8. Manual Stabilization Treatment. Source: [9].

Kramer et al. studied the viability of reverse sensitization and found it to be effective [9]. They used a portable ceramic pad heating panel similar to the one shown in Figure 8.

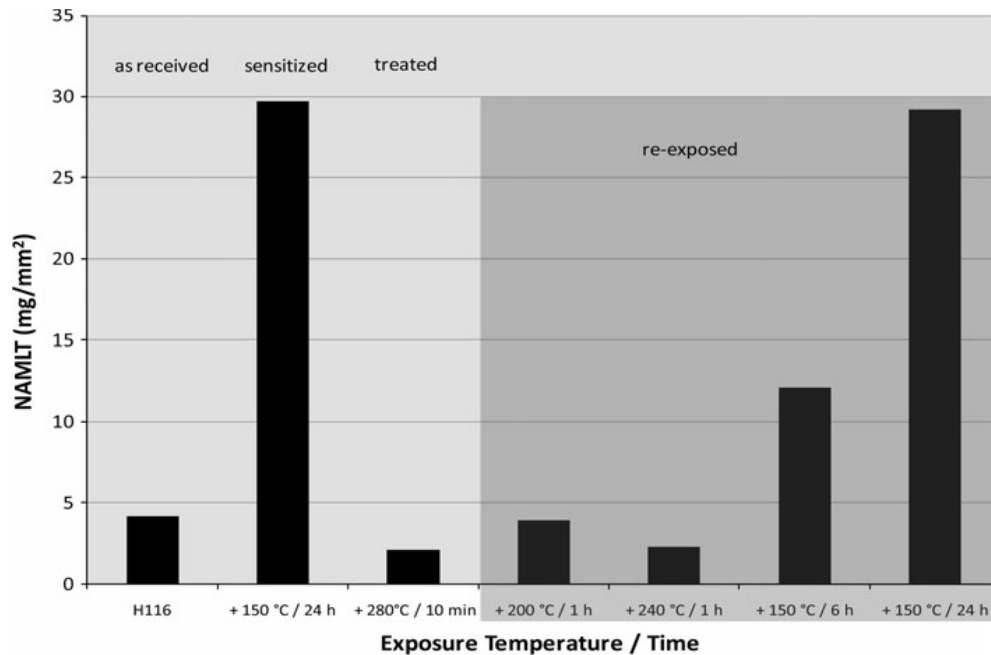
Figure 10. NAMLT Results of Reverse Sensitized AA 5456-H116.
Source: [9].

This technique is analogous to the stabilization heat treatment done in the manufacturing process of rolled Al-Mg plate. Illustrated in Figure 9, Kramer et al. applied a heat treatment following cold work (rolling). This heat treatment is performed at a temperature below that which would result in the material being annealed, allowing it to retain the increased strength from cold work. This is a narrow temperature band. If the temperature is too low, sensitization is accelerated by β -phase precipitates forming in the supersaturated solid solution matrix [9]. If the temperature is too high, β -phase precipitates will dissolve into the solution but the material will be annealed, reducing the strength gained by the manufacturer's strain hardening [9]. It was also verified that the material could be sensitized again when exposed to elevated temperatures, as shown in Figure 10.

Kramer et al. identified the temperature range of 240–280 °C, applied for time periods of as little as 10 minutes, as showing promise for use as a technique to reverse sensitization. Using a Nitric Acid Mass Loss Test (NAMLT) [14] to assess the degree of sensitization, this heat treatment technique was verified to decrease the degree of sensitization.

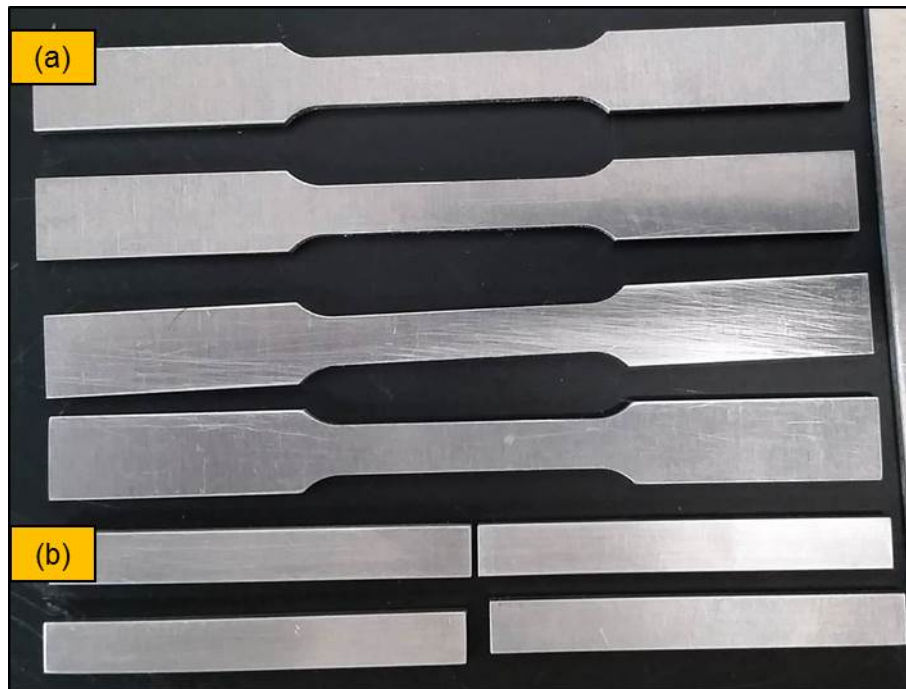
Figure 19. (a) Tensile and (b) NAML Test Specimens

Specimens were prepared in accordance with ASTM B557M [18] using the specifications for flat sub-sized specimens, illustrated in Figure 18 and shown in Figure 19a. The sub-size specimens were used due to the small amount of material available for testing. These were flat specimens with a 32 mm initial gage length and 100 mm overall length. Both the tensile and NAMLT specimens were fabricated on a mill with Trim Sol® cooling liquid applied during fabrication. Care was taken to avoid high temperature during the fabrication process which could have affected test results and microstructure by annealing the material.

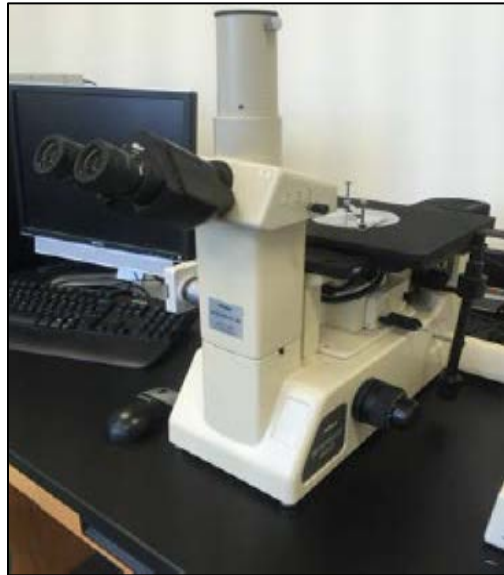
Figure 20. Nikon Epiphot 200 Optical Microscope

A Nikon Epiphot 200 optical microscope was used for imaging, shown in Figure 20. The microscope is capable of magnifications of x25, x100, x200, x500, and x1000. It was used to determine rolling direction of the specimens so test specimens could be prepared according to the applicable ASTM specifications.

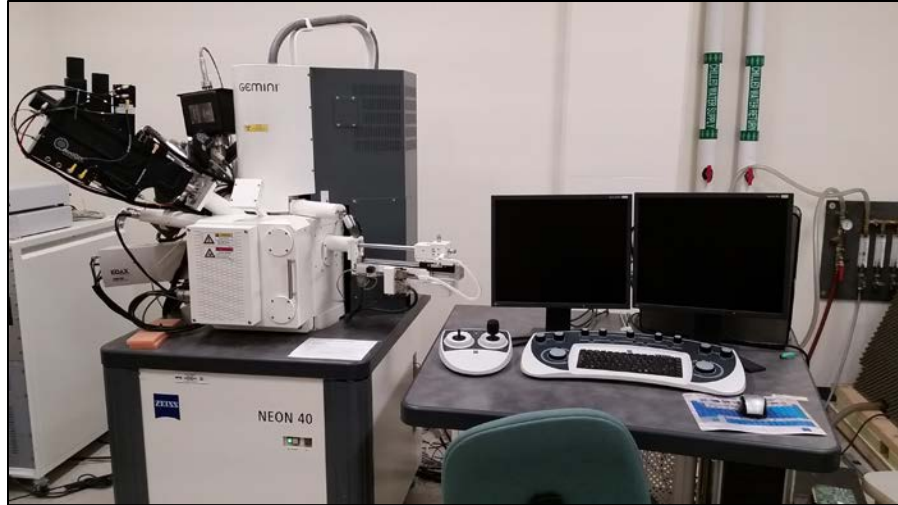
Figure 21. Zeiss Neon 40 Field Emission SEM

A Zeiss Neon 40 field emission SEM, shown in Figure 21, was used to determine grain size, grain orientation, and grain boundary precipitate morphology and distribution. Secondary and backscatter electron images were captured with backscatter diffraction (BSD) being the primary mode of characterization at energies between 15 and 20 keV, with up to 1.32×10^{-6} mA beam current and a working distance of approximately 6.5 millimeters.

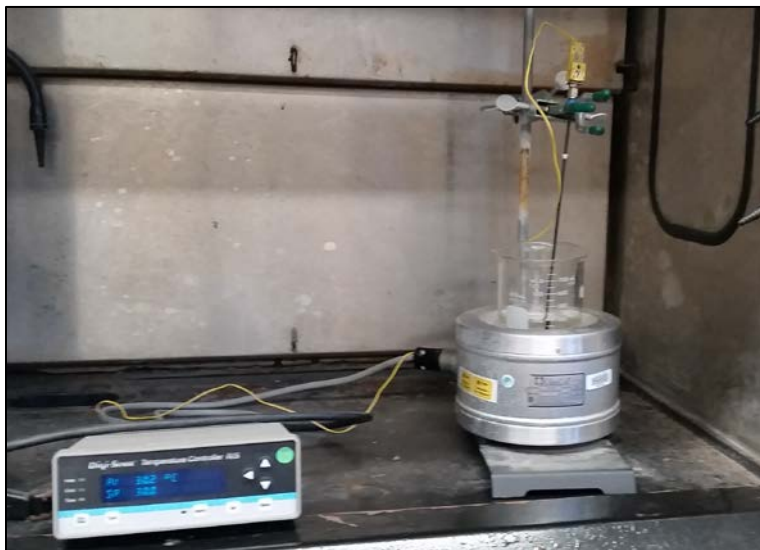
Figure 22. NAMLT Apparatus

The β -phase precipitate is anodic to the surrounding Al-Mg solution. It is preferentially corroded by the nitric acid, resulting in a loss of mass or the grain boundary precipitate. Using the test apparatus shown in Figure 21, test specimens were immersed in nitric acid for 24 hours, with temperature maintained at 30°C (86°F). Specimens were weighed and the total surface area determined before and after the test. The resulting loss in mass indicates the degree of sensitization. According to ASTM G67 a mass loss greater than 25 mg/cm² is susceptible to intergranular corrosion, which can lead to stress corrosion cracking [14].

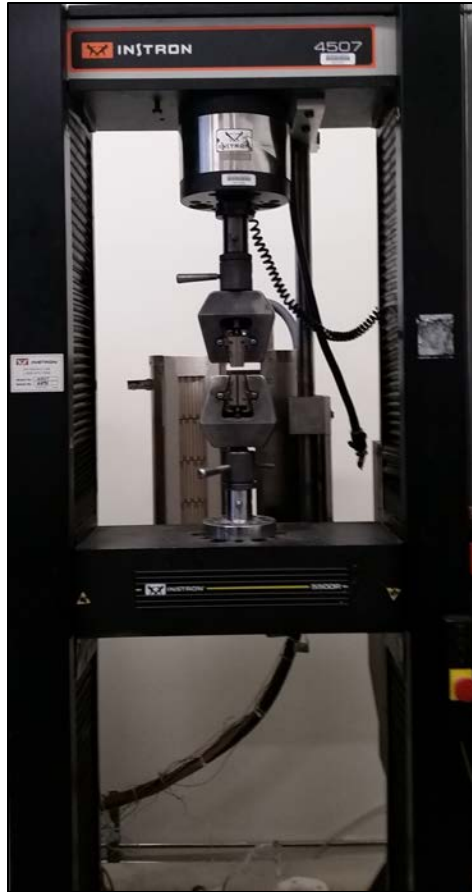
Figure 24. Instron Model 4507

Tension tests were conducted on an Instron model 4507 using Bluehill software (Figure 24). The apparatus employed wedge-type grips. Specimens were subjected to constant extension rate until they failed, using a cross-head speed of 1 mm/minute. Load-elongation data were reduced to engineering stress versus engineering plastic strain curves. Engineering 0.2% offset yield strength values were used to determine whether the reverse sensitized specimens' yield strength was within specifications for in service use outlined in ASTM B928 Standard Specification for High Magnesium Aluminum—Alloy Sheet and Plate for Marine Service and Similar Environments [1]. As-received and shipboard sensitized specimens were tested for comparison.

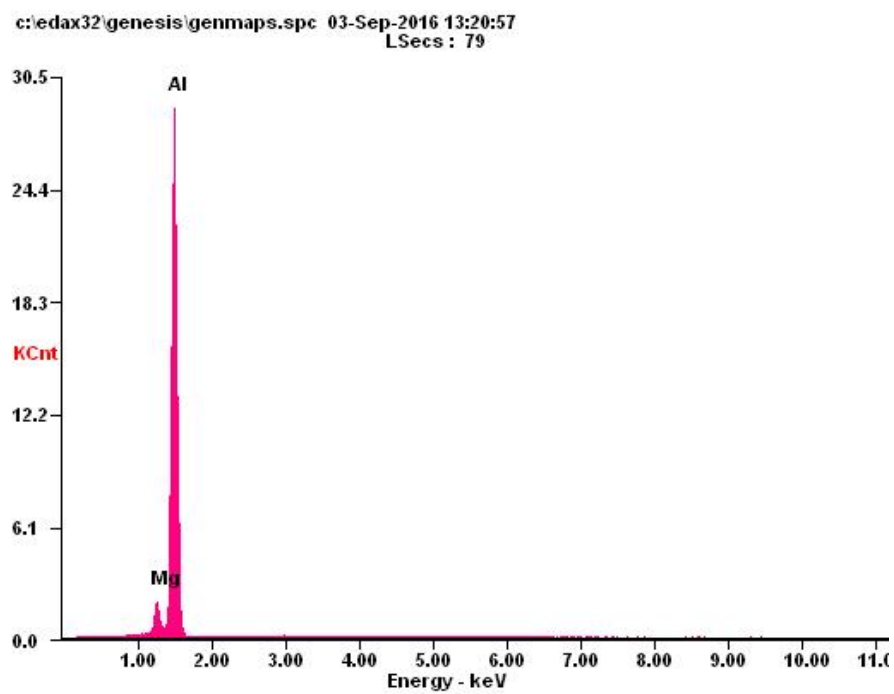
Figure 35. EDS Spectrum of Heat Treated AA5456

Element	Wt%	At%
MgK	05.15	05.68
AlK	94.85	94.32
Matrix	Correction	ZAF

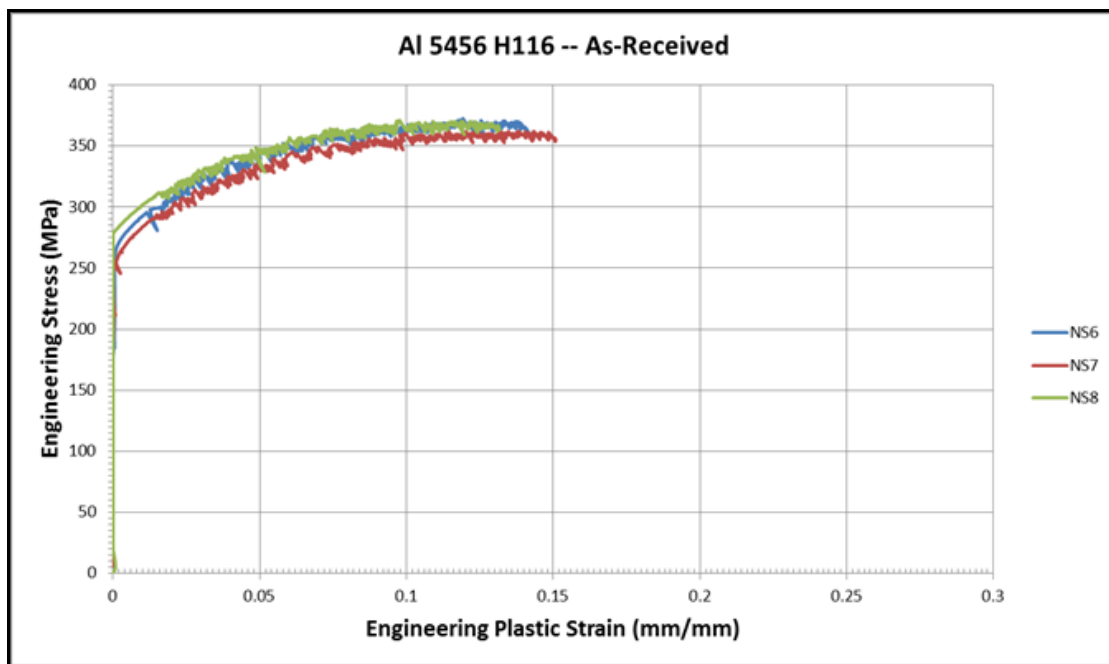
Figure 40. As-received AA 5456 Stress Strain Curve

UTS (MPa)	YS (MPa)
N6	373	271
N7	363	261
N8	371	284
Avg	369	272

Another noteworthy result is that yield strength was affected by sensitization much more than UTS. As Mg comes out of solution to form β -phase precipitate, less Mg is in the matrix to provide the solid solution strengthening as designed. Yield strength is affected more because, as plastic deformation occurs during tension testing, dislocations multiply and the material again becomes strain hardened up to fracture [22]. This is also reflected in the “saw tooth” pattern of the plastic region, shown in Figures 40 through 43.
